A machine vision system for quality grading of painted slates

Ovidiu Ghita, Tim Carew and Paul F. Whelan

The major aim of this chapter is to detail the technology associated with a novel industrial inspection system that is able to robustly identify the visual defects present on the surface of painted slates. The development of a real-time automated slate inspection system proved to be a challenging task since the surface of the slate is painted with glossy dark colours, the slate is characterised by depth profile non-uniformities and it is transported at the inspection line via high-speed conveyors. In order to implement an industrial compliant system, in our design we had to devise a large number of novel solutions including the development of a full customised illumination set-up and the development of flexible image-processing procedures that can accommodate the large spectrum of visual defects that can be present on the slate surface and the vibrations generated by the slate transport system. The developed machine vision system has been subjected to a thorough robustness evaluation and the reported experimental results indicate that the proposed solution can be used to repla

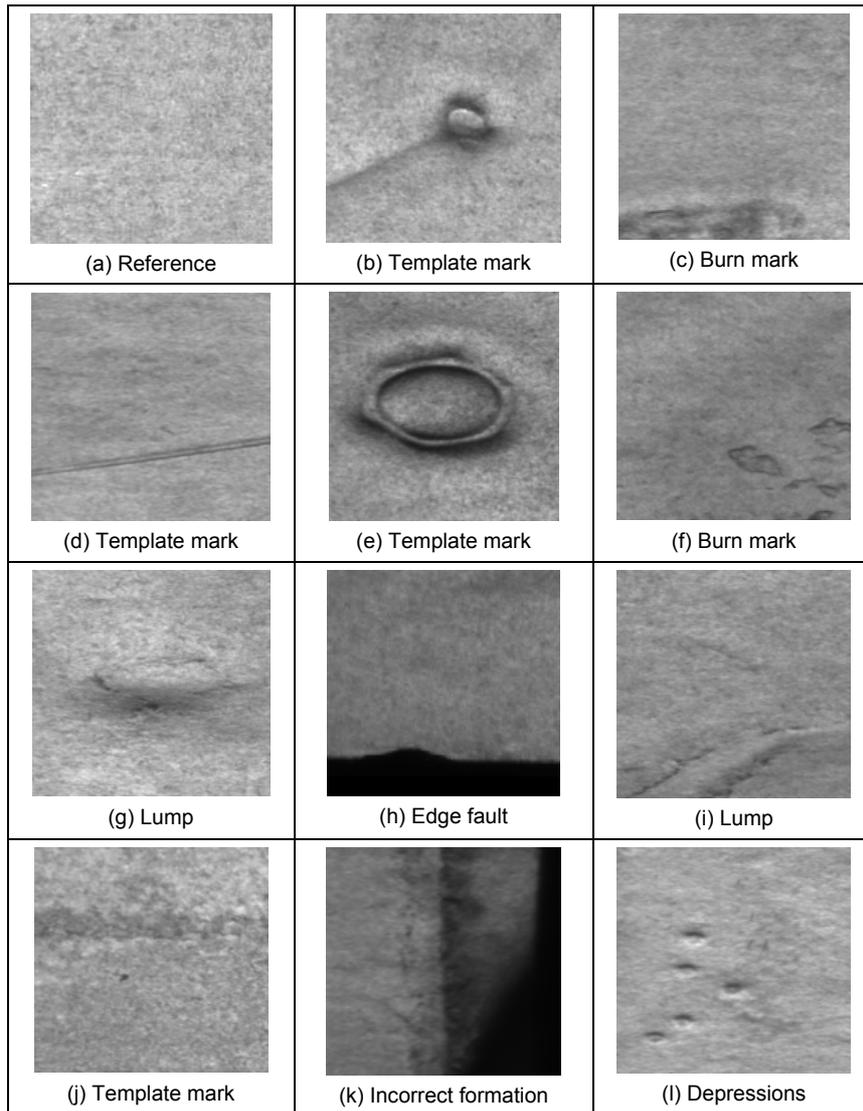
Figure \$.1. A selection of representative substrate defects including template mark, lump, depressions, burn mark and incorrect slate formation. (a) Defect-free slate section. (b-l) Defective slate section.

To further aid the reader in the process of interpreting the variability of the visual defects that may occur during the slate manufacturing process, a number of representative paint and substrate defects are depicted in Figures \$.1 and \$.2, where Figure \$.1(a) illustrate a defect-free slate image section.

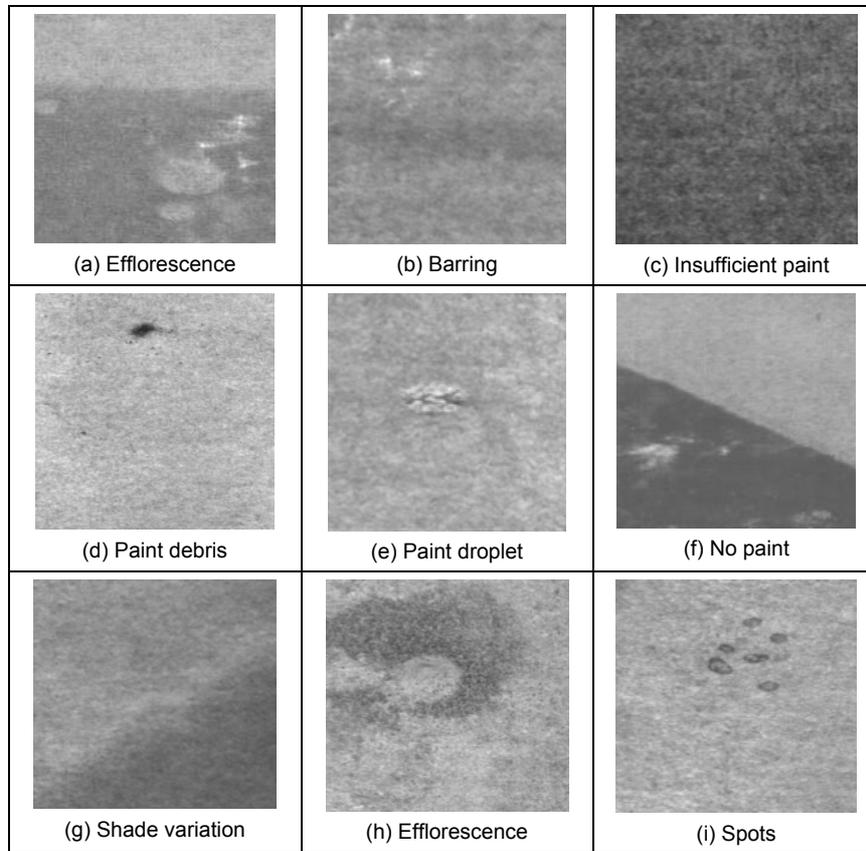
Figure \$.2. A selection of representative paint defects including efflorescence, no paint, insufficient paint, paint droplet, shade variation, paint debris, barring and spots.

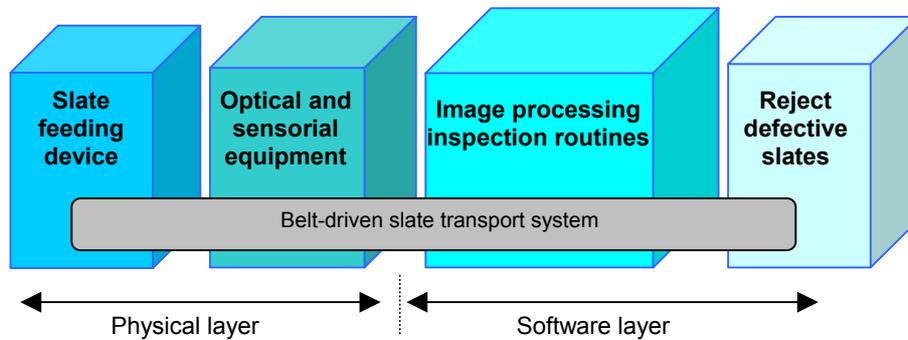
Figure \$.3. Overview of the designed slate inspection system.

In order to devise a flexible machine vision solution, we have adopted a modular approach in our design. The prototype slate inspection system was built to closely replicate the manufacturing environment and consists of three main modules. The flowchart detailing the logical connections between constituent modules is illustrated in Figure \$.3. All modules of the developed inspection systems are controlled by an industrial PC which is also the host of the image processing software that has been designed to perform the classification of the slates into acceptable and defective products.

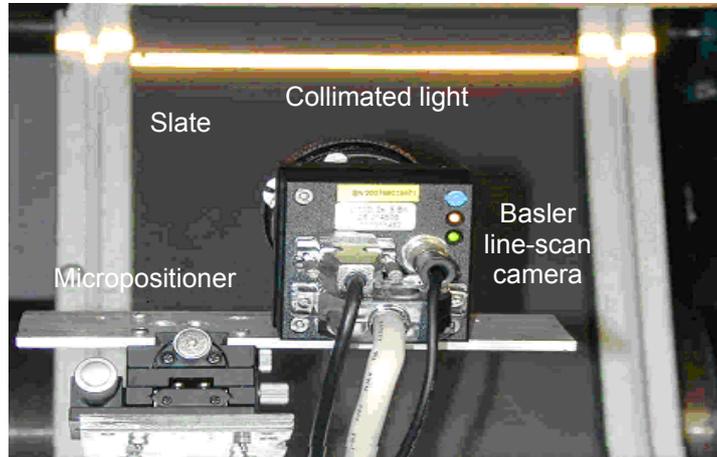
Figure \$.4. The Basler-2K line scan camera mounted on a xyz micropositioner that facilitates fine adjustments of the camera line view.

The second module of the slate inspection system is represented by the optical and sensing equipment. In the development of our slate inspection sensor we have used a Basler L102 2K-pixel line-scan camera which is fitted with a 28 mm standard machine vision lens (aperture set to 2.8). The line-scan camera operates at a scan frequency of 2.5 KHz. To allow a facile calibration of the sensing equipment with the illumination unit, the line-scan camera was attached to a micropositioner that allows fine adjustments to the camera view line with respect to the xyz coordinates. The camera set-up is illustrated in Figure \$.4. The interface between the camera and the industrial PC computer was facilitated by a Euresys frame grabber. Another important component of the optical and sensing module is represented by the illumination set-up. In our implementation we have design a collimated light arrangement that relies on the strong reflective properties of the slate's surface (full details about the implementation of the illumination set-up used in our design will be provided in the next section of this chapter). The last component of this module is represented by a proximity sensor which has the role to trigger the image acquisition process prior to the arrival of the slate at the inspection line.

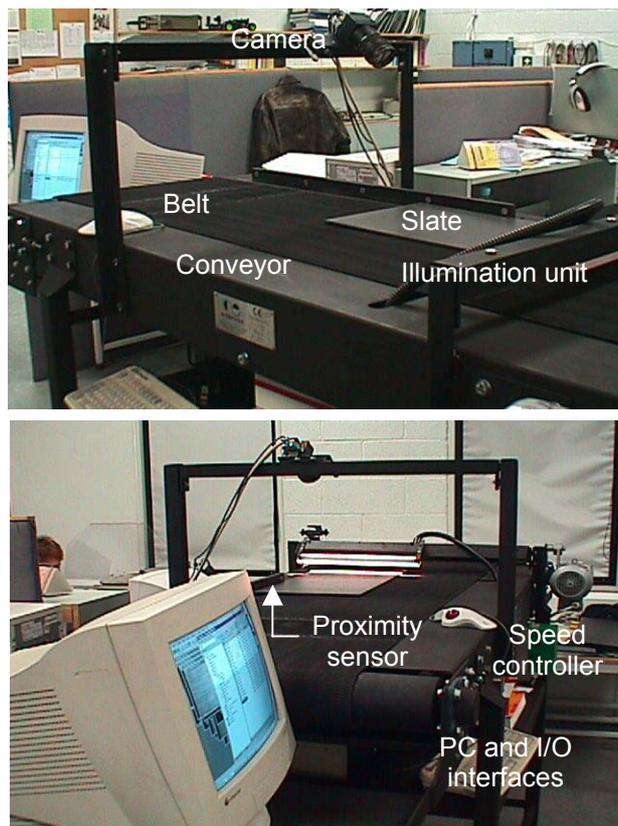
Figure \$.5. The prototype slate inspection system [1].

The final module of the system performs the identification of the visual defects in the image data captured by the line-scan camera. While the development of a single procedure to identify all types of defects detailed in Table 2 was not feasible, the proposed inspection algorithm has been also designed in a modular fashion where each component has been tailored to identify one specific category of defects (the proposed inspection algorithm will be detailed in Section 5.6). The developed prototype slate inspection system is illustrated in Figure 5.5.

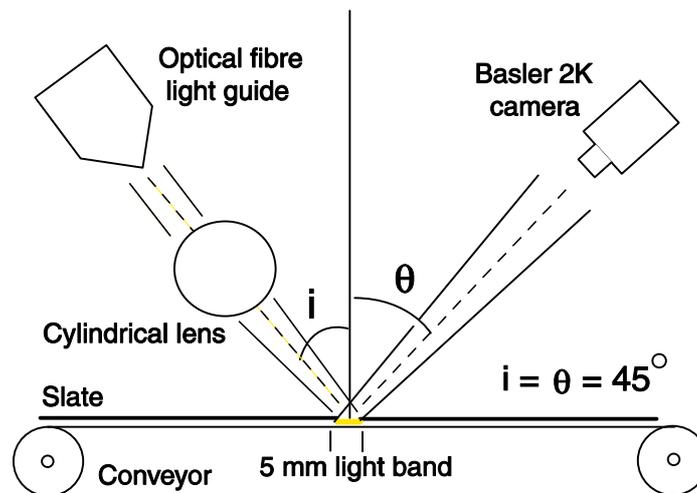
Figure \$.6. Schematic detailing the developed illumination set-up.

The collimated illumination solution adopted in our implementation is building on the fact that the paint defects have reduced gloss levels (except paint droplets) than the slate areas of acceptable quality. Substrate defects are associated with errors in slate formation and the resulting appearance of these visual defects also results in a reduction of the light arriving at the line-scan sensing element. The illumination arrangement comprises two Fostec DCR III 150W lamp controllers, a Fostec 30" fiber optic light line and a cylindrical lens. A schematic description of the devised illumination set-up is illustrated in Figure 5.6. The lamp angle of incidence has been set to 45° and the camera view angle was located symmetrically to 45°. The lamp intensity level was set to

approx. 80% with respect to the maximum level and the camera exposure time was set to 400 μ s at a scan frequency of 2.5 KHz. This setting allows us to image the slate with a cross pixel resolution of 0.221 mm and a moving pixel resolution of 0.244 mm. This pixel resolution is sufficient to properly image the entire range of defects that are present on the surface of the painted slates.

Although the illumination set-up detailed in Figure \$.6 generates sufficient illumination levels required for image acquisition at production line speeds, one issue that we encountered was the narrow band of the focused collimated light. Indeed, when we positioned the lens to attain perfectly focused collimated light, the resulting light band was only 5 mm wide (see Figure \$.6) and the process required to align the camera line view for a distance of 30" requires adjustments with a precision of less than one degree ($\delta\theta < 1^\circ$). To facilitate such adjustments we mounted the camera on a micropositioner as indicated in Section \$.4. However, the alignment of the camera line view to the longitudinal axis of the light band was not the only issue we had to confront during the development phase of the illumination set-up. One of the most challenging problems was the variation in depth profiles across the slate due to slate bowing that is sometimes associated with slates that have acceptable quality with respect to inspection criteria. The small slate bowing was found to range from negligible to 5 mm over the slate length and up to 2 mm along the slate width. Although the variation in depth profile does not affect the functionality of the product, it has introduced a substantial challenge that has to be accommodated by the proposed illumination solution. While the depth profile non-uniformities raises and lowers the absolute position of

the projected light band with respect to the camera line view, this practically compromises the image acquisition process. To give some insight into the problem generated by slate bowing, if we consider that the incidence of the light band and the camera view angle are set symmetrically to 45° as illustrated in Figure 5.6, if the slate raises the light band with 1 mm, then the reflected light is shifted to 1.5 mm in opposite direction with respect to the camera view line. Since the slate possesses some elasticity, a pneumatic solution that forces the slate into an uniformly planar shape during inspection would be feasible. However, there are several disadvantages associated with such mechanical solutions that are used to force the slate into the nominally flat shape. The first is related to fact that the painted surface can be easily damaged when the pneumatic device is operated at high production line speeds, and secondly the development of such mechanical system would be problematic taken into consideration the non-smooth characteristics of the underside of the slate. As a mechanical solution to force the slate into a uniform flat position proved unfeasible, we elected to defocus the lens that is used to collimate the light generated by the Fostec fiber optic light line. This produces a wider light band but this is achieved at the expense of reduced collimation. To compensate for the reduced intensity levels caused by de-collimation, we used the spare capacity in the lamp controller. Following a simple trigonometric calculation, the lens has been defocused to generate a 25 mm wide light band, an increase that is sufficient to accommodate the slate bowing effects in the range [0, 5 mm] and the vibrations caused by the slate transport system.

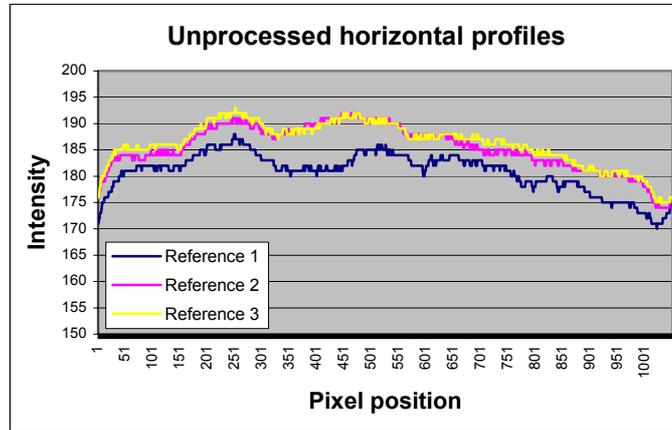
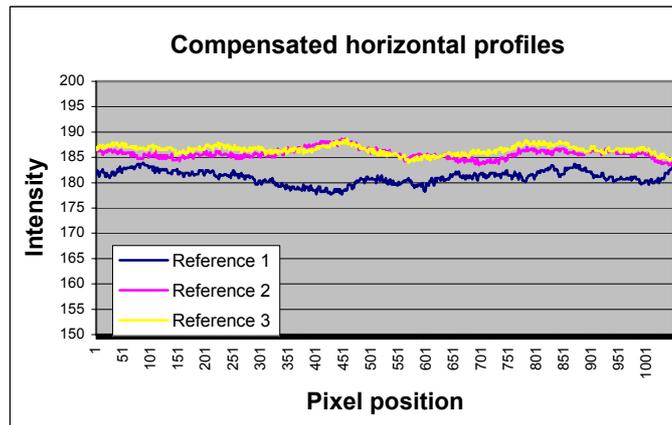
Figure \$.7. Compensation for the non-linearities in the response of the light unit along the horizontal direction. (a) Unprocessed horizontal light profiles. (b) Compensated horizontal light profiles.

The last issue that we confronted during the development of the illumination set-up was the development of software routine that was applied to compensate for the non-linearities in the horizontal profile (longitudinal axis) of the light band. As the fiber optic is 30" long, the profile of the light band shows stronger illumination levels towards the central position when compared to the intensity level supplied at the left and right extremities of the slate. This is illustrated in Figure 5.7(a) where the unprocessed horizontal light profiles for three reference slates are depicted. To compensate for this uneven response of the illumination unit, we have subtracted the mean intensity level (calculated from all reference slates that are used to train the system) from the unprocessed data and the obtained results are averaged with respect to each pixel position to compute the light compensation map. This light compensation map encodes the deviations from the expected mean intensity level and it is directly used to linearise the unprocessed horizontal profile (see Figure 5.7b). The application of the horizontal profile linearisation reduced the light variation in the horizontal direction from 20 per cent to 2.5 per cent. The linearisation of the response of the illumination unit in the moving direction was deemed unnecessary, as the light intensity variation in the vertical axis shows negligible variation due to de-collimation.

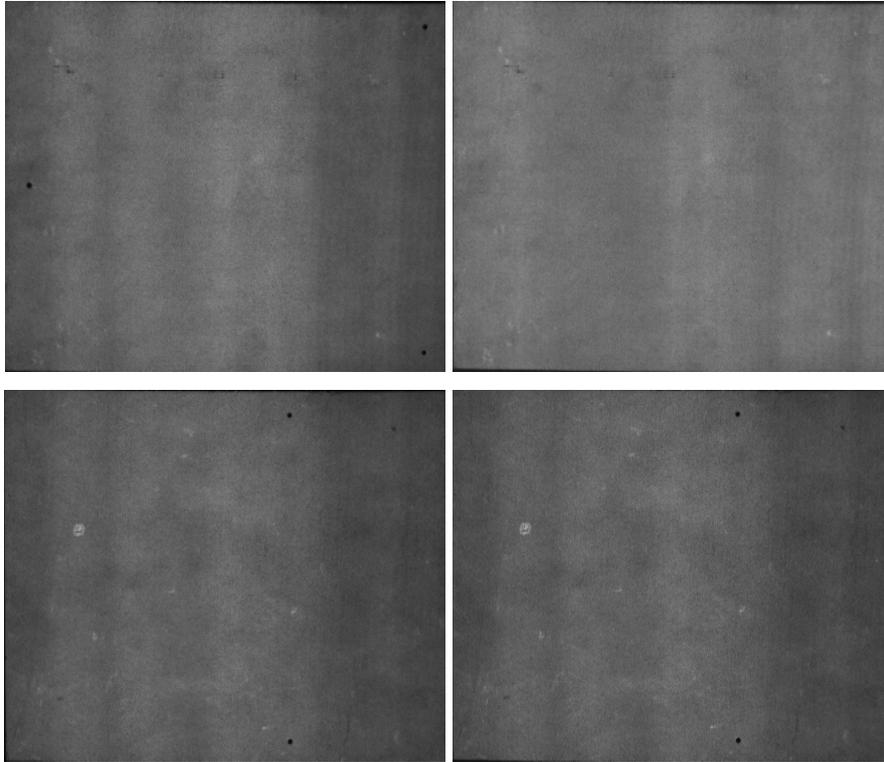
Figure 8.8. Nail hole verification procedure. (Top row) Slate that passes the nail hole verification test. (Bottom row) Slate that fails the nail hole inspection procedure. In the last column the images resulting after the nail hole inspection procedure are displayed. Note that the image that passes the nail hole verification test has the nail hole areas filled with pixels information from adjacent slate surface data to be ready for defect inspection.

Once the corners of the slate are identified, the next operation verifies if the nail holes are correctly positioned with respect to slate boundaries. The nail hole detection involves a threshold-based segmentation technique since the intensity of the optical signal associated with the nail hole is substantially lower than that given by the slate surface. The developed nail hole checking procedure starts with the identification of the hole that is located on the left hand side of the slate surface. The detected xy coordinates of the nail hole are compared to pre-recorded values and if the procedure passes inspection conditions then the algorithm proceeds with the verification of the remaining two nail holes that are located close to the right-hand side top and bottom slate corners. If the nail checking procedure triggers the absence of a nail hole or an incorrect nail hole placement with respect to slate boundaries, the slate is classed as defective and put aside for rejection or re-work. If the nail holes are correctly positioned, then the algorithm fills them with adjacent slate surface pixel information to prevent the identification of visual faults when the slate data is subjected to the automatic inspection process. Figure \$.8 describes graphically the nail verification procedure.

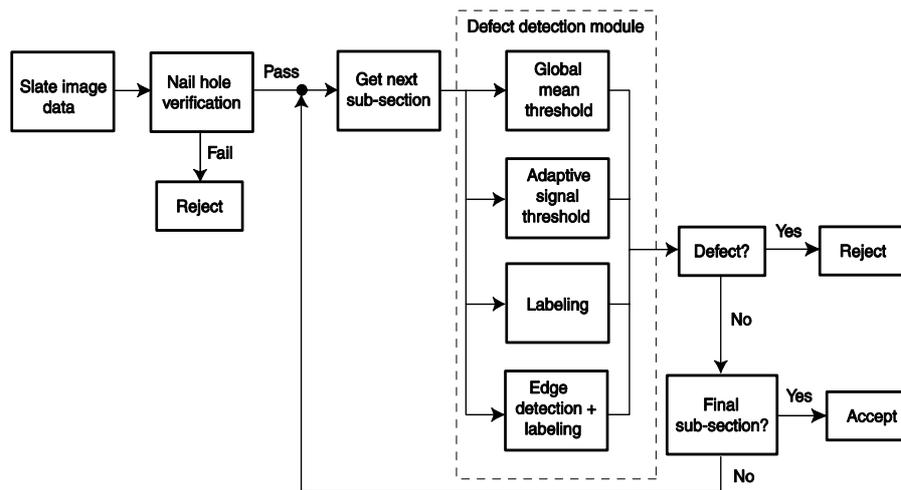
Figure \$.9. Overview of the slate inspection algorithm.

Based on the analysis of the grayscale values associated with reference and defective image sections, we have devised an algorithm which consists of four distinct computational strands - in this approach each component has been designed to strongly respond to a narrow category of visual defects. The block diagram of the developed slate inspection algorithm is depicted in Figure \$.9 and the main components can be summarised as follows:

- Global mean threshold method
- Adaptive signal threshold method
- Labeling method
- Edge detection and labeling method.

Each component depicted in Figure \$.9 is applied to each 128×128 segment of the slate image and the results are compared to experimentally determined thresholds. Each component of the slate inspection will be detailed in the remainder of this section.

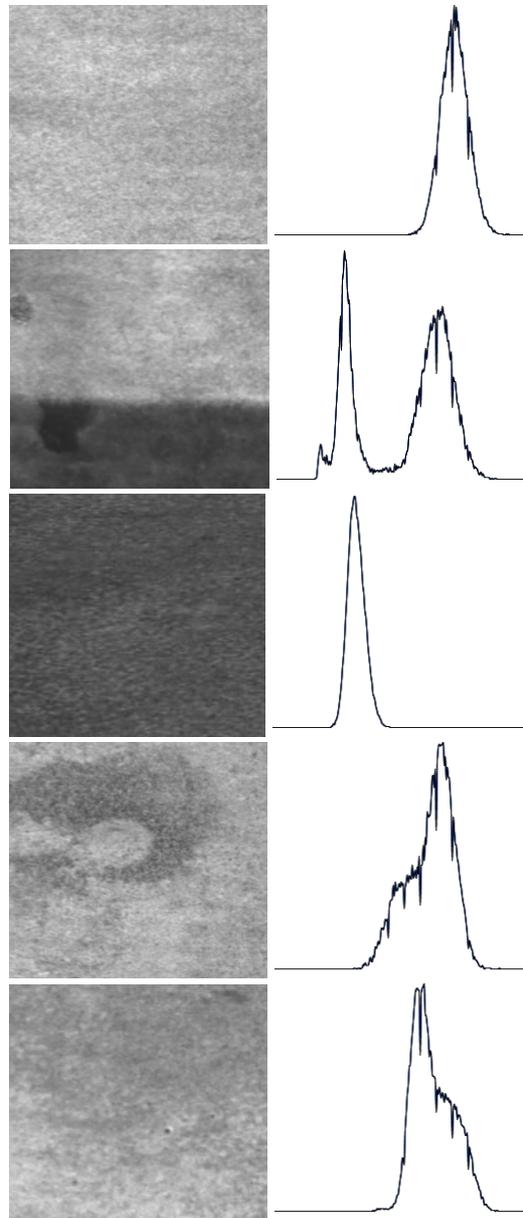
Figure 10. Gross defects identified by the global mean threshold method. (Left) Images showing a reference slate section and slate sections exhibiting gross visual defects. (Right) The corresponding grayscale distributions. From top to bottom, reference (non-defective) slate section, slate section detailing an insufficient paint defect, slate section detailing an orange peel defect, slate section detailing an efflorescence defect and slate section detailing a shade variation defect.

This component has been developed to evaluate the mean gray level of the image section with the aim of identifying the gross defects that may be present on the surface of the slate. In this regard, the mean value for each subsection is compared to an experimentally determined mean value and this approach proved to be effective in detecting a range of defects including missing paint, orange peel, efflorescence, insufficient paint and severe shade variation.

In spite of its simplicity, this method proved to be the most reliable in detecting defects that cover large areas of the slate surface, defects that have a dramatic impact on the grayscale distribution when evaluated at local level (see Figure 10). To increase the robustness of the proposed method a global mean threshold has been employed to identify defects such as missing paint and orange peel and grade specific thresholds were experimentally determined for the identification of low contrast defects such as efflorescence, insufficient paint and shade variation.

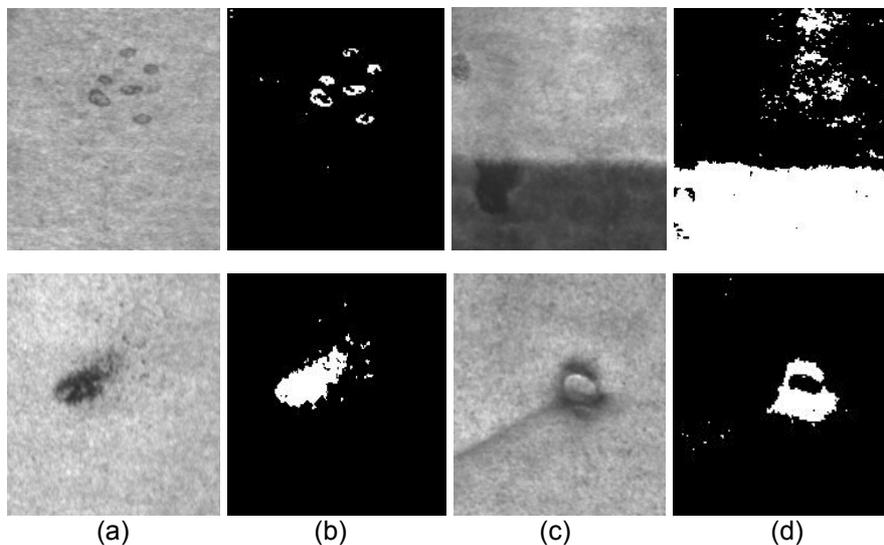
Figure 11. Visual defects identified by the adaptive signal threshold method. (a,c) Defective slate sections. (b,d) Resulting images after the application of the adaptive signal threshold method. Top row - paint defects such as paint droplets and insufficient paint. Bottom row - substrate defects such as burn mark and template mark.

Our experimental measurements indicated that the slate texture induces a grayscale variation for non-defective image sections in the range $[\text{mean} - 30, \text{mean} + 30]$. When analysing the 128×128 image sections for visual defects, to avoid the occurrence of false positives we need to locate the paint and substrate defects outside the range $[\text{mean} - 40, \text{mean} + 60]$. By thresholding the image data with these values a relative large category of visual defects can be robustly identified. The defects detected by this method include missing paint (where less than 50 per cent of the image section is defective), localised paint faults such as paint debris, droplets and spots and structural defects generated by an improper slate formation.

This method has not been found useful in detecting low contrast visual defects such as barring and elongated depressions whose gray levels are within the grayscale variation generated by the slate texture. Representative paint and substrate defects that are detected by the adaptive signal threshold method are depicted in Figure \$.11.

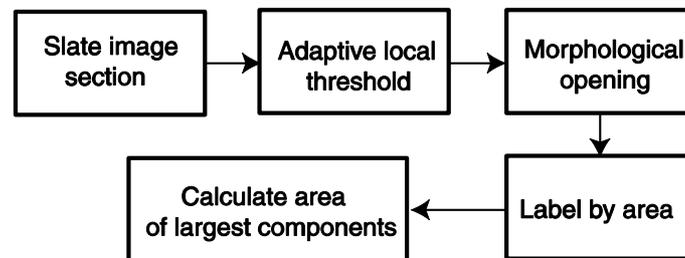
Figure \$.12. Overview of the labeling method.

The aim of this method is to identify the visual defects that cover a relative small area with respect to the overall size of the analysed 128×128 image section. This method consists of several steps that are illustrated in Figure \$.12.

The first step of the labeling method converts the image corresponding to the analysed slate section into the binary format by applying a local adaptive threshold operation [28]. The aim of this step is to identify the relative bright and dark regions with respect to the local gray mean value. The second step involves the application of a binary opening operation with the aim of removing the small unconnected regions that are caused by the non-regularized slate texture and the image noise. The third step involves the application of the labeling by area operation [28,29] to provide an unique label for each disjoint white blob in the image resulting from the morphological opening step. Since the small blobs are often associated with the slate texture, the largest blobs are of interest as they are generally caused by visual defects. Thus, to reduce the impact of the randomly distributed blobs that are generated by the slate texture, we compute the area of the ten largest blobs and this feature is used to discriminate between reference and defective image sections. This method proved effective in identifying high contrast defects such as droplets, paint debris, spots, efflorescence and template marks. A small collection of visual defects that are identified by the labeling method is depicted in Figure \$.13.

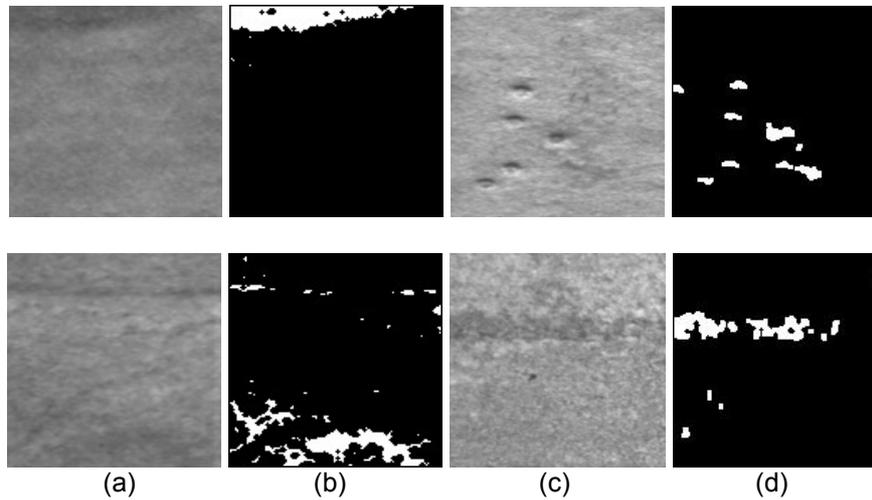
Figure 13. Visual defects identified by the labeling method. (a,c) Defective slate sections. (b,d) Resulting images after the application of the labeling method. Top row - paint defects such as shade variation and paint droplets. Bottom row - substrate defects (template marks).

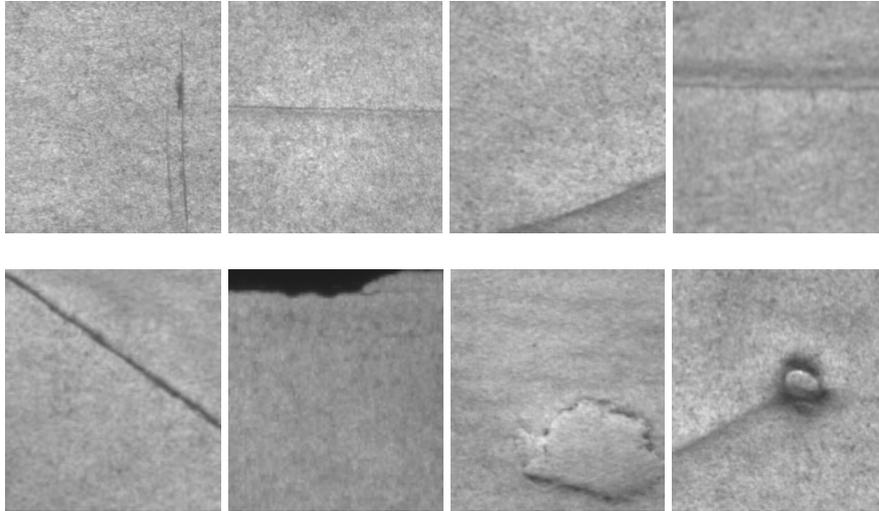
Figure 14. Visual defects identified by the edge detection method. (Top images) Paint defects. (Bottom images) Structural defects.

The last component of the inspection algorithm has been designed to specifically detect the narrow elongated defects, as the previously described methods were not sufficiently accurate in identifying this type of slate faults. As this defect identification method is based on the application of first order derivative operators (Sobel edge detector), prior to edge extraction the image data is subjected to median filtering. The experimental measurements carried out during the development phase revealed that narrow defects such as depressions and elongated substrate marks have a shallow intensity profile and as a result gaps are present in the resulting edge structure. To compensate for this issue a morphological closing operator is applied and the resulting data is labeled by area for further analysis. Similar to the approach used for labeling method, the largest ten components were retained and their collective area is used as a discriminative feature to grade the slate section under analysis as acceptable or defective. Figure 14 depicts some representative defects that are identified by the edge detection method.

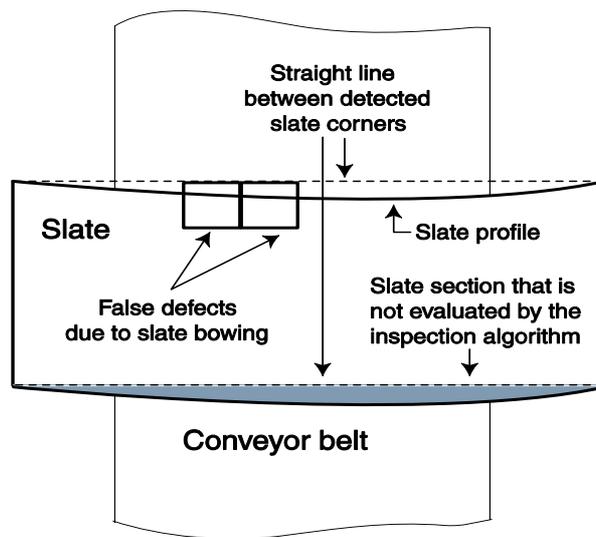
Figure \$.15. False defects generated by slate bowing.

The slate inspection algorithm detailed in Section 3.6 performs the identification of the visual defects on each 128×128 segment of the slate image. To facilitate the tiling of the slate image into sub-sections, the slate was approximated with a rectangle that is obtained by connecting the corners of the slate that have been identified during the slate segmentation process (see Section 3.6.1). This procedure worked very well when applied to flat slates, but generated false triggers when applied to slates that are affected by depth profile variations (slate bowing). These false positives are caused by the displacements between the straight edge obtained by connecting the slate corners and the curved edge of the imaged slate. This slate edge positioning errors lead to an incorrect image tiling and this generates situations when the 128×128 image segments include non-slate image data (background information), while on the opposite side of the slate there are sections of the slate that are not investigated by the inspection algorithm (see the shaded area in Figure 15). This is illustrated in Figure 15 where the problems caused by slate bowing are illustrated. An example that shows the occurrence of false positives due to slate bowing is depicted in Figure 16.

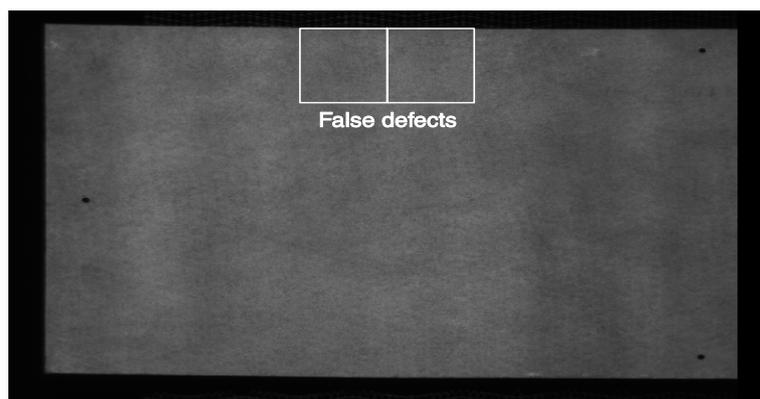
Figure \$16. Example illustrating the false defects caused by slate bowing effects.

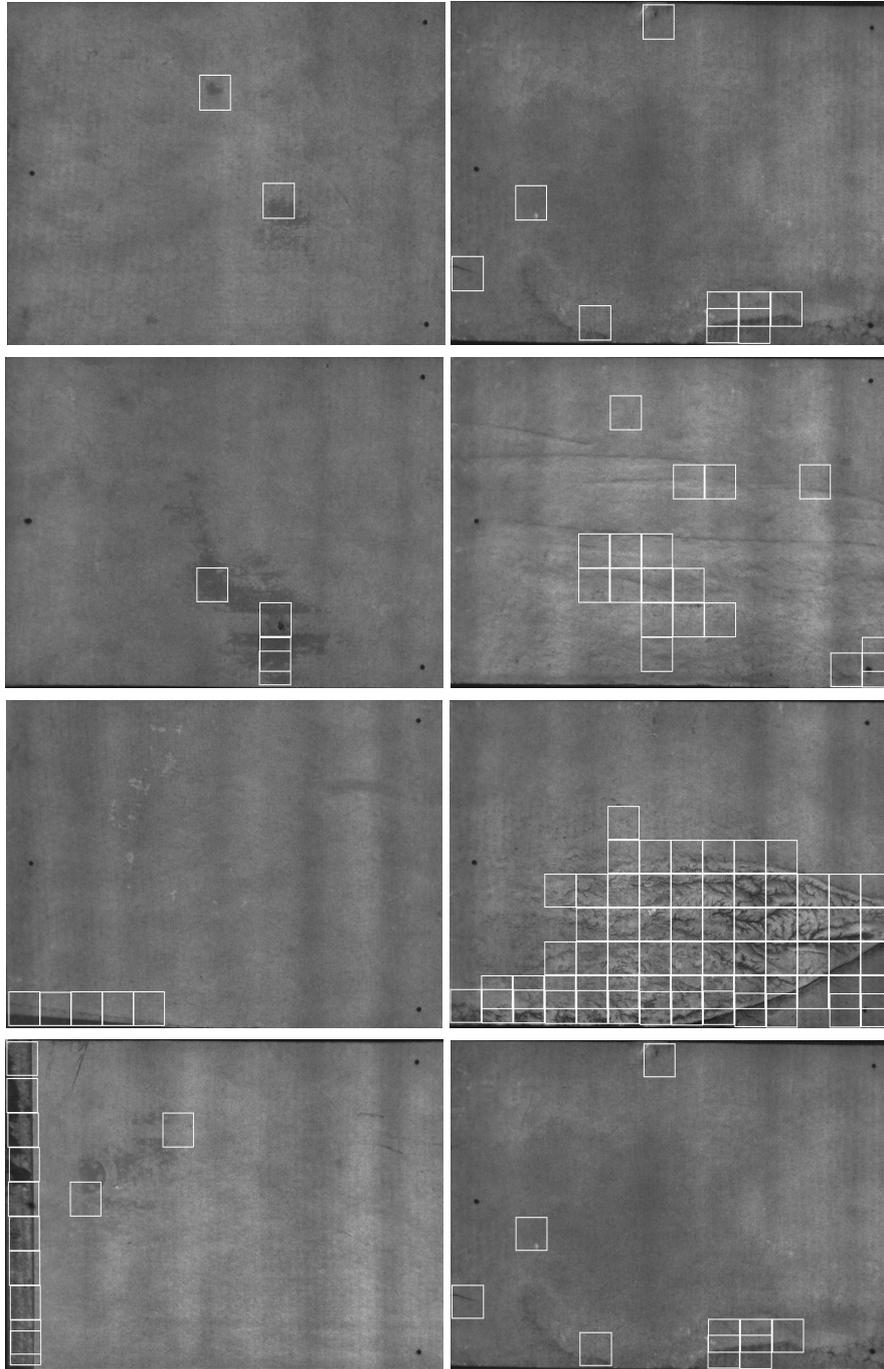
Figure \$.17. Identification of the visual defects on a selection of defective slates that exhibit a large variety of paint and substrate defects.
