A Vision System for Detecting Paint Faults on Painted Slates

T. Carew, O. Ghita and P. F. Whelan

Vision Systems Laboratory, School of Electronic Engineering, Dublin City University, Dublin 9, Ireland
(Tel: +353-1-700-5869; Fax: +353-1-700-5508 ; E-mail: {carewt, ghitao, whelanp}@eeng.dcu.ie)

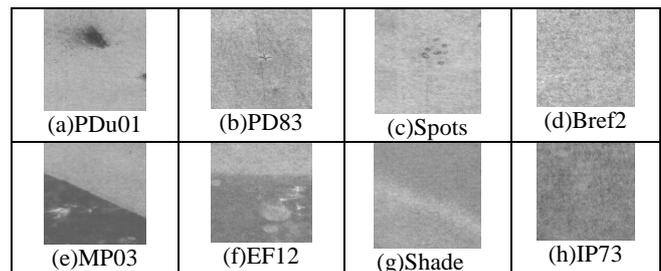
Figure 1: A selection of defects found on the slate. From top left, paint dust, paint droplet, spots, reference, no paint, efflorescence, shade variation and insufficient paint.

Defects are broadly classified as being of type paint and substrate. Substrate faults are marks, dirt, lumps, depressions

and edge faults. Paint faults are sub-divided into stains, nozzle and heating types: nozzle types include missing paint, insufficient paint, paint droplets, spots and paint dust. Heating types include shade variation and burn mark. Sizes range from sub-millimeter to hundreds of square millimeters.

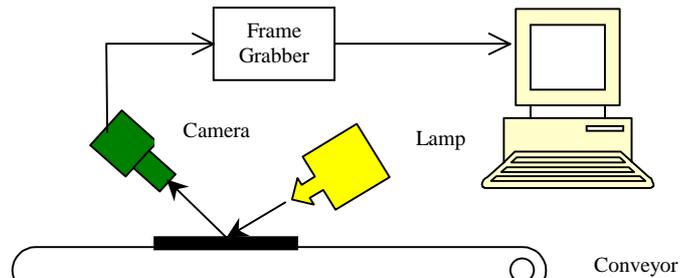
Figure 2: Block diagram of test bed.

A Basler Model L102 line scan CCD camera was used as the sensing device and the video data was captured and transferred to computer hard drive using a Eursys model Multi frame grabber card. An f28 mm lens was used with aperture set to 2.8. A micro-positioner was attached to the camera to facilitate fine adjustment of camera view line. The slate was illuminated using a fiber light guide illuminated by a 150W halogen bulb driven by a Schott-Fostec DC regulated lamp controller. No light intensity feedback sensor was used. A cylindrical lens was placed in front of the fiber light guide. This arrangement creates a very intense and collimated source. The camera was fixed in position 700 mm from the slate and lighting was

separated from the slate by a distance of 84 mm. Camera control and frame capture was implemented using the Eursys Easygrab software environment.

A guide for slate conveyance was made from Bosch extrusions. The slate is inserted between slots in the extrusion and ensures the slate travels smoothly in the X and Y-axes. There is scope for 5 mm movement in the Z-axis. Slate weight will keep it on the lower edge of the slot and there should not be any Z-axis movement. Slates were pulled by hand along the extrusions and moved past the inspection point at relatively constant speed. Frames of width 2,000 pixels and length 600 pixels were captured and transferred to computer memory. Regions of interest were extracted from these frames and filed for later analysis. The Neatvision [10] image analysis software was used to implement off-line analysis.

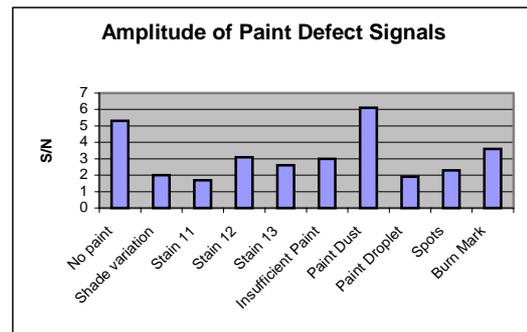
Figure 7: Fiber Light Guide Results

The collimated lighting method is preferred because light intensity levels are sufficient and all defect categories can be detected. It suffers from the disadvantage that signal level can be affected sufficiently by depth profile variations to render defect detection difficult and in extreme situations, impossible. The effects of low-level depth profile variation can be removed by image pre-processing. A morphological white top hat is a candidate algorithm. This would introduce an additional level of processing carrying considerable computational overhead and should be avoided. Medium level depth profile variation causes considerable gray level shifts, which are difficult to distinguish from large area paint faults such as shade variation. Further testing is being carried out to determine if an optical or image-processing solution can be found for this problem.

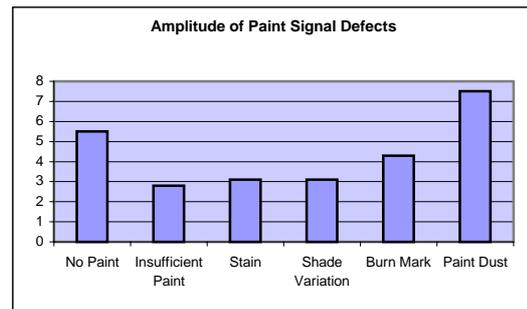
Figure 8: Diffuse lighting Results

The diffuse lighting method works very well for detection of gross paint faults. Defect detection is not adversely affected by depth profile non-uniformities of up to 5mm. The low

pass filtering effect of the slow scan speed averages out much of the slate texture. This has the advantage of lowering noise levels and the disadvantage of removing useful information such as tiny defects. Small paint faults such as spots and paint droplets are not detected using diffuse lighting.

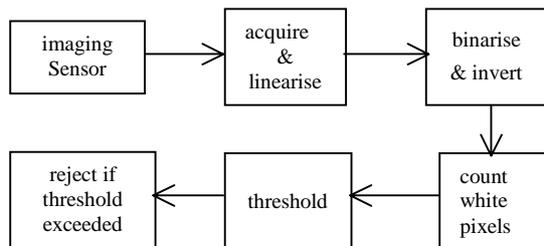
Figure 10: Common processing loop applied to slate images.

All images were thresholded using a double threshold with lower threshold set at 150 and upper threshold set at 210. Any image data between these set points is deemed acceptable quality and any pixel data outside these set points is considered to be associated with a defect.

The image was inverted and subjected to a 4-connected erosion to remove noise. The balance of white pixels were counted and compared to a threshold. The common processing loop was applied to all images with good results. Defects with a signal-to-noise ratio larger than 2.0 will be detected using this threshold setting. All paint faults listed in table 1 were successfully detected. The erosion step was removed to successfully detect the small size paint defects of paint droplet and spots.
